#### Forsythe II Multiparty Monitoring Group (MMG) April 22, 5:00 PM to 8:00 PM Virtual Meeting Meeting Summary – FINAL

#### SURFACE FUEL EXERCISE

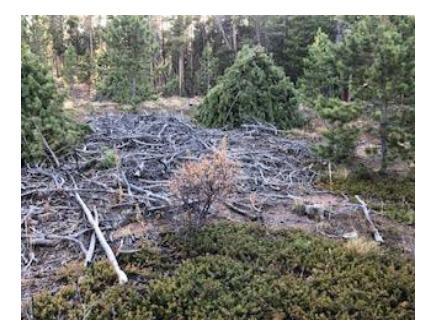
#### Picture 1: Lodgepole Pine - Unit 2

- The surface fuels in this picture are primarily coarse wood that is three to four inches in diameter, so it is difficult to estimate the total surface fuel loading in this photo.
- The surface fuels in this photo are from a half-acre patchcut treatment conducted in 2002. The regrowth in this stand from the 2002 treatment was treated as a regeneration thin unit in Forsythe II. The piles in this picture are from the Forsythe II regeneration thin treatment.

- The amount of surface fuels in this photo looks like a fire hazard. Layers of surface fuel material have been built up from repeated treatments; however, the surface fuels look like they are in an isolated patch. If this photo represents the amount of surface fuel on a broader scale, it would be more concerning, but it is difficult to assess the fire hazard from this photo alone.
- It may be beneficial to distribute the surface fuel material to a greater extent.
- The surface fuels look close to the ground, which means there is less space underneath the material to help facilitate a fire.

- Due to the dry climate, the slash does not degrade quickly, which is why much of the material is still on the ground 18 years after the original treatment.
- The piles in the picture are a result of the contractor piling the material instead of scattering it during the most recent regeneration thin treatments. The amount of surface fuel material that was scattered from 28 years ago looks comparable to the amount of material that was piled during the Forsythe II regeneration thin treatments.

- There are not many wildlife species that can use this stand as habitat. However, small mammals may use the litter on the ground to move to the edge of the forest.
- There are bushes on the edge of the photo that could provide forage for animals

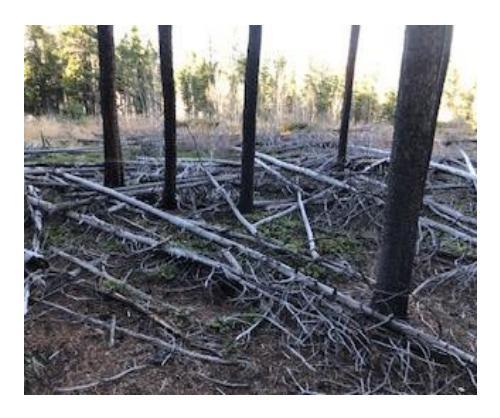
# Picture 2: Lodgepole Pine – Unit 2

A contractor cut this stand 18 years ago, and the surface fuels have not decomposed as a result of the local climatic conditions. The surface fuels are composed of the material that the contractor scattered and from blown downed trees due to the adjacent opening.

- It looks like there is air underneath the surface fuels, which can help facilitate a fire.
- There is a fire hazard in this photo as a result of fine surface fuel material being next to larger surface fuel material.

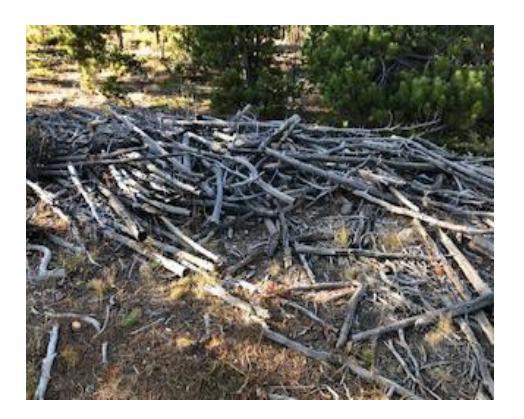
### Picture 3: Lodgepole Pine – Unit 2

- A contractor conducted this treatment. The surface fuels in pictures 1, 2, and 3 are the result of patchcuts that were conducted in the early 2000s. Many of the surface fuels from these patchcuts look like they were either purposefully scattered or they were made into loose burn piles or berms that eventually collapsed.
- There were piles left on the periphery of patchcuts from the Winiger treatment, and it resulted in a continuous circle of surface fuels around the edges of the patchcuts.
- The contractor was likely following guidelines set at the time; however, the treatment guidelines that this past contractor used are different than the ones the USFS sets in the present.

If these surface fuels represent an isolated pile and there are one of two of these per acre, then there would not be wildfire concerns. If this picture was representative of the larger landscape, then there would be wildfire concerns.

- These surface fuels represent an ideal wildlife pile because there are tunnels for small mammals to travel across the landscape. This pile may be what it would look like if burn piles are allowed to flatten over time and become a wildlife pile.
- Wildlife biologists can determine whether animals are using wildlife piles by either trapping or looking for signs of animal activity, like scat or bite marks. It is time consumptive to look for these signs, so assumptions are being made about whether small mammals will use a wildlife pile based on knowledge on how animals move across the landscape.
- It would be better to strategically spread wildlife piles across the landscape to create a wildlife corridor for small mammals. Having wildlife piles in a continuous circle around a patchcut would be a barrier for the movement of larger animals.

There is an opportunity to conduct surface fuel treatments. Any surface fuel treatments under Forsythe II must occur within the boundaries of Forsythe II because that is the geographic area for

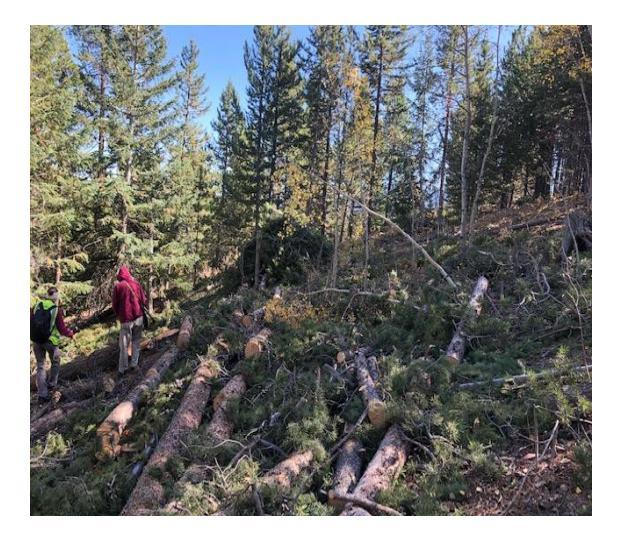
### Picture 4: Lodgepole Pine - Unit 5

The surface fuels in this photo are the result of a lop-and-scatter treatment in an aspen unit. The piles in this treatment area are not near other piles on the landscape.

- The surface fuels are a jackpot of fuel and a wildfire concern. The slash on the ground could cause the boles of the tree to ignite, and the surface fire could transition to the crowns of the nearby trees. These surface fuels would also increase the residence time of any fires.
- These surface fuels could be piled to reduce the surface fuel loading. Another option could be to pile and burn the finer material while leaving the boles on the ground to reduce the opportunity for finer material to set the boles on fire.

- The intent of this treatment was to cut down conifer trees so that they would not continue to drop seeds and propagate more conifer trees in the aspen stand in the absence of fire.
- In a year or two, all the needles will fall off the logs, which will allow sunlight to reach the surface and stimulate aspen regrowth.

- These surface fuels look like a wildlife pile. The bigger logs could provide habitat to weasels, and the finer surface fuel material may provide cover to small animals.
- This pile would be more beneficial if it was located near other similar piles. If there are pockets of conifer stands in aspen units, the treatment could be designed to create a transportation corridor to assist the movement of wildlife species through an aspen unit.

- The current practice to manage slash in aspen stands is to lop-and-scatter instead of piling and burning. There could be an option to modify the piling method in aspen stands. It would require a supplement to the Decision Notice (DN).
- The surface fuels in this photo are the result of manual treatments. If the treatment was done mechanically, they could have removed the bigger logs and left some of the finer material.

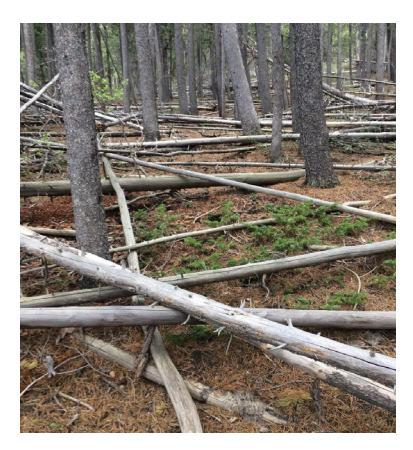
### Picture 5: Lodgepole Pine – Unit 1

- Unit 1 is the only unit that is entirely within the Town of Nederland boundary but is still located on USFS land. The Town of Nederland requested that the USFS treat this area. The original plan for Unit 1 in Forsythe I was to clear cut half of the 40 acres.
- This picture is representative of other areas in Unit 1.

- This lodgepole pine forest is on a north-facing slope, which means that the stand has a lower risk of fire. Although north-facing slopes have a lower risk of wildfire, there are still opportunities for the forest to burn, which can then spread to the surrounding areas. Part of the natural progression of a lodgepole pine stand is for a fire to ultimately thin the stand, so a fire on a north-facing slope would remove the entire stand.

- The proximity of this stand to the Town of Nederland may change how much fire risk is acceptable. Having lodgepole pine stands in that stage of maturity close to Nederland may present an unacceptable risk, even if it is on a north-facing slope. There are also other potential ignition sources from human activity because the stand is close to Nederland.

- Firefighters may be able to access this area during a wildfire depending on the severity of the fire. On a moderate day, it would burn slowly, and hand crews could use chainsaws to make hand lines. During more severe conditions, hand crews could not access the area, and they would have to use bulldozers or aerial resources to make it safe for hand crews to access.

This lodgepole pine stand is reaching maturity. Many of the lodgepole pine trees in this stand are older, and the weaker and diseased trees are beginning to die. There are very few lodgepoles in the

understory because sunlight has not been able to get through to the understory. The surface fuels in this picture are a result of blowdown and the self-thinning process.

- Depending on the surrounding forest type, elk and other large mammals would avoid moving through this stand.
- In the winter, the layers of trees would create pockets of snow through which subnivean species would move.
- In the summertime, some mid-size species, like martens and bobcat, would use this area as habitat, but there is little forage overall for animals.
- When deciding how to design a treatment for wildlife, a wildlife biologist would look at the habitat in the surrounding area using Geographic Information Systems (GIS) and aerial photos. If the habitat is similar across the landscape, the preference of the wildlife biologist would be to design a treatment that creates a diversity of habitats; if the habitat is unique in the context of the landscape, then the preference of the wildlife biologist would be to not treat it.

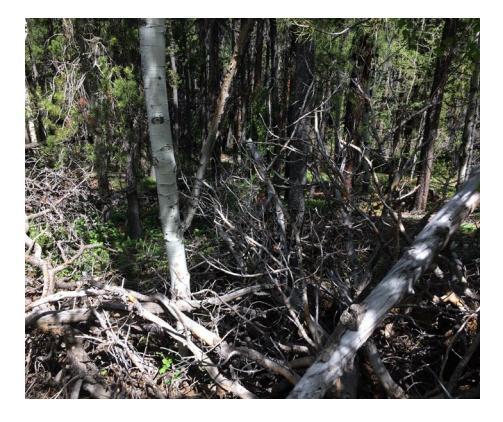
### Picture 6: Lodgepole Pine - Unit 1

The stand in this photo may be adjacent to a road, so these surface fuels may be the result of windthrown trees being pushed to the side of the road following a wind event.

- The surface fuels in this photo would burn easily, and there are many opportunities for a surface fire to transition to the overstory in this stand. The surface fuels in this photo should be piled and burned or made into wildlife piles.
- It is difficult to assess the fire hazard of this stand because the context of the surrounding forest is unknown. If the surrounding forest is dense, then having jackpot fuels and ladder fuels close to a dense stand would represent a high fire risk.

This lodgepole pine stand appears to be naturally thinning.

These surface fuels would be great denning habitat.

*Other Perspectives* This photo represents an area where there should be a surface fuels treatment.

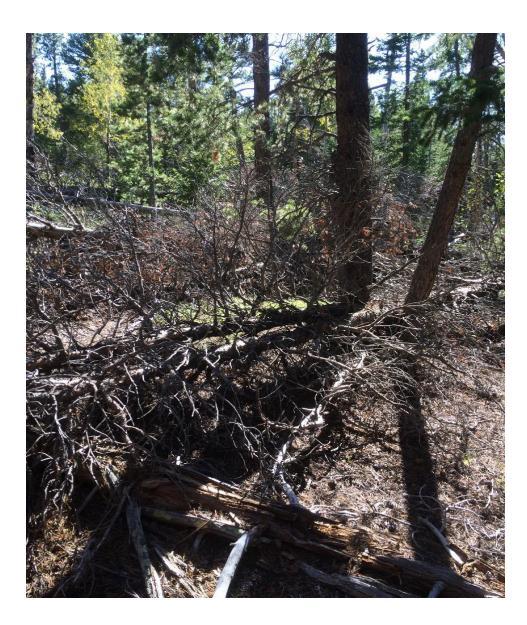
## Picture 7: Lodgepole Pine – Unit 10

Unit 10 has many of these downed trees in areas that are a quarter- or half-acre in size.

- Dead and downed trees are receptive to embers and are at a higher risk of burning and starting a fire. The surface fuels in this photo could be treated to reduce fire risk.
- Surface fuel treatments and thinning trees where necessary may be a better solution to reduce fire risk than clearcutting or patchcutting because patchcuts and clearcuts lead to windthrown trees. If surface fuels were removed and the sunlight could reach the ground, there would need to be a way to prevent regrowth from later becoming a fire hazard.

- There were several potential explanations as to why the tree fell. The tree could have fallen as a result of natural self-thinning. The downed tree could be the result of a nearby pathcut or clearcut increasing wind speeds. The tree could have also been infected by insects or disease.
- The degradation of the log in the foreground indicates that it has been in the area for a while. The tree is breaking down and beginning to incorporate into the soil, which is a part of the nutrient cycle. The degradation of this log indicates that fire has not been in this stand for some time. The stand could use a fire in the understory.

- Animals would use these surface fuels less as denning habitat and more as cover. Raptors would then use the mid-story branches for hunting hares and squirrels.
- The scattered surface fuels are beneficial to wildlife. Animals may move between the denser habitat in the background of this photo to this area using the scattered surface fuels.

• Because this stand is farther from Nederland, it may be more appropriate to leave more surface fuels in this area for wildlife.

There is a tradeoff between the amount of surface fuels left to nourish the soil and create habitat and the amount of surface fuels that pose a fire risk. Determining how much surface fuel is appropriate depends on who is asked, the amount of surface fuel in the surrounding landscape, and the proximity of the stand to Nederland.

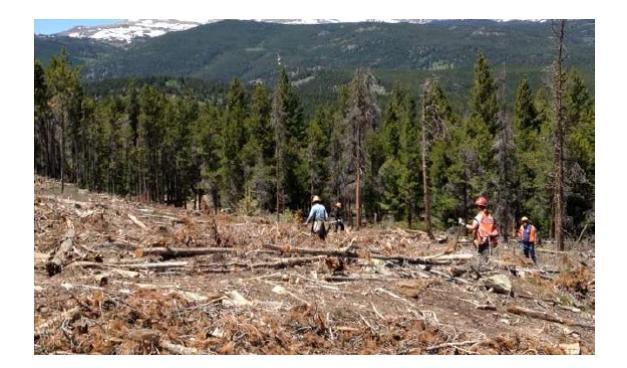
## Picture 9: Lodgepole Pine Clearcuts – Unit 1

- This picture is of a lodgepole pine clearcut one year after the clearcut was conducted. The picture itself is from about six years ago. This patchcut is adjacent to the ski slope above Nederland and is next to a road.
- The contractor mechanically treated this unit and had to bring felled trees back to the unit to improve nutrient cycling.
- This clearcut is probably around 15 acres in size.

- These surface fuels are at risk of burning quickly across the landscape when conditions are hot and dry and wind speeds are high. A fire may or may not be able to transition to the tree crowns depending on what materials are on the periphery of the clearcut.

- Overall, these clearcuts have resulted in a small increase in fire size but not an increase in fire frequency when compared to an untreated stand in the same location. There have been several small fires in these clearcuts, but the openness of the area allows firefighters to suppress the fires quickly and easily. This accessibility for firefighters can make a large difference when compared to the inaccessibility of untreated stands with dead and downed surface fuels. The latest fire was about three-quarters of an acre.

- The proximity of the clearcut to the road is beneficial for firefighters who can then access the area quickly. The road can also act as a barrier to stop the fire, which is particularly beneficial during the COVID-19 situation when firefighting resources are more limited.

- Timing is an important aspect of determining fire risk. As the fuel decomposes, it turns into duff and will not be as conducive to spreading fire. At that time, grasses and ten- and hundred-hour fuels will be the material left on the landscape. Although there might not be a high fire risk in the long-term, these treatments leave surface fuels on the ground with needles and other combustible material that would make it difficult to fight a fire in high-wind conditions in the near-term. The timing aspect of fire risk involves determining whether long-term benefits outweigh near-term risks.

- On a big wildfire day, this treated area may be the difference between using aerial support to fight a fire or reinforcing this treated area with hand crews to suppress the wildfire. Wind conditions limit when firefighters can use aerial resources to fight fires. The upper limit of wind speeds for which it is acceptable to use aerial resources is 35 miles per hour.

- In a clearcut, there should be surface fuels left on the ground to help the soil retain moisture and nutrients and to prevent weed species from growing on the landscape. Leaving surface fuels on the ground for nutrient cycling is a long-term consideration to benefit the health of the forest.
- The amount of surface fuels in this picture is representative of the amount of surface fuels left following a mechanical treatment.
- The USFS staff in this picture are planting trees. They are doing this to reinput nutrients back into the system.
- In the clearcuts, many of the seedlings are being sunburned and scorched and are not surviving due to an increase exposure to the sun and heat.

- Wildlife could use this area once vegetation begins to grow. Many large mammals would stick to the periphery of this clearcut not because there is any barrier to movement, but because there is no cover.
- The downed material does provide some cover, but having another pile or two could be beneficial to create some extra stopping places for small mammals.
